Job Reference

CLIENT: Steel Company in U.A.E.

LOCATION: Mussafah, Abu Dhabi

EQUIPMENT: Electrolizer Tank

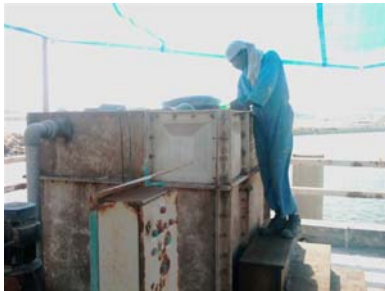
Electrolizer Tank

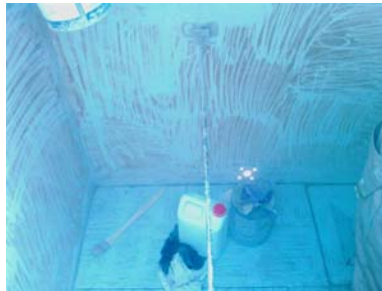
Preparation of the surface

SOLUTION: After abrading the surface, SolarFill was used as a fillet on all seams. These areas were then overlaid with a 150 mm strip of SolarTech type 55 laminate and cured using a 400W UV lamp.

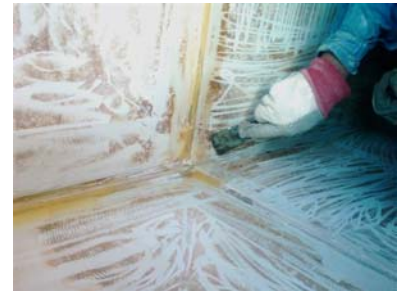
SolarSeal was used to seal joints between panels

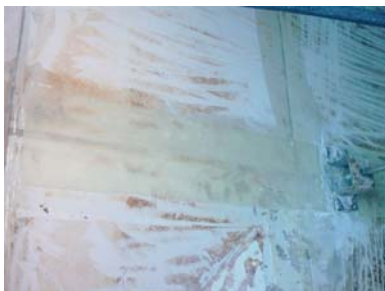
Joints are sealed by single layer stripe of SolarTech Sheet Laminate

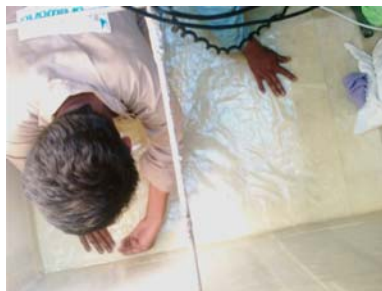
Application of the SolarTech Sheet Laminate

Following this the repair and protection of the tank was completed with two layers of SolarTech type 55 applied in opposing directions with SolarSeal applied between layers.
