Job Reference

CLIENT: Sugar Manufacturer in U.A.E.

LOCATION: Jebal Ali Free Zone, Dubai

EQUIPMENT: Underground Seawater Storage Tank

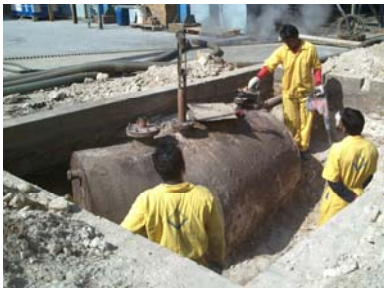
PROBLEM: Buried carbon steel tank is continuously being exposed to soil stress & negative electrode causing severe corrosion to tank body.

Equipment before SolarTech application

SOLUTION: The surface of the carbon steel tank was mechanically abraded to ST2 Std. Tank was then cleaned with acetone followed by the application of 1st coat of SolarSeal, followed by SolarTech VE55 applied wet on wet.

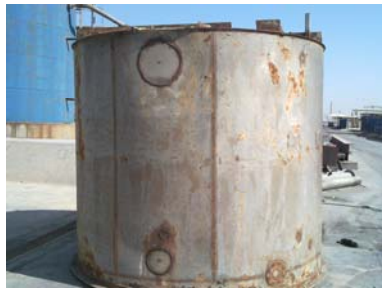
Damaged storage tank

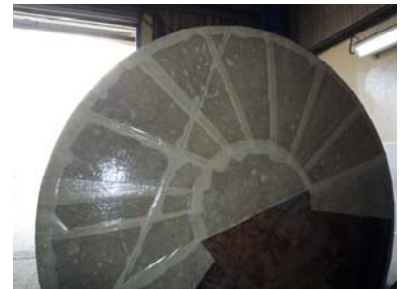
Application in process

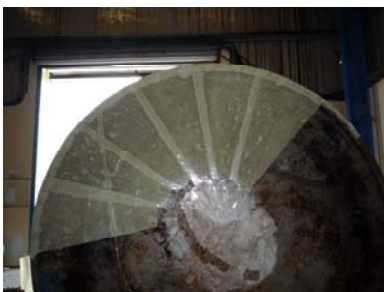
Application in process

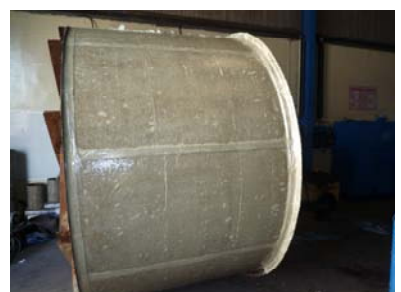
Finished application
