Job Reference

CLIENT: Major Oil Company in U.A.E.

EQUIPMENT: Buried Gas Pipeline

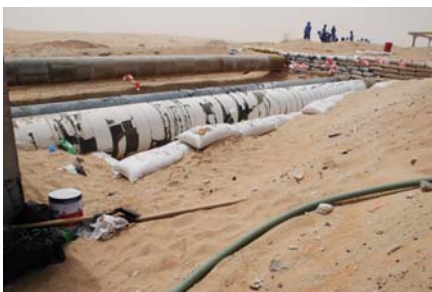
PROBLEM: Underground Gas Transfer Lines originally coated with a “Bitumastic” Tape Wrap system. During service the pipes move underground an action caused by expansion and contraction of the pipe, this action causes damage to the Wrap System from abrasion and subsequently exposes the pipe to direct contact with the surrounding desert sand and corrosive chloride elements which if allowed to prevail will cause the pipe to corrode.

Damaged Bitumastic Tape Wrap System

SOLUTION: Existing wrap system has been removed manually and is then “Grit-Blasted” to SA 2.5 with an anchor profile of 75 to 80 Microns using Garnet B as a medium. The pipe is immediately cleaned with the use of 1st Grade ACETONE and followed with a single coat of SolarSeal Resin Primer to a WFT of 250 to 300 Micron. The primer coat of SolarSeal is then cured using natural UV Light (Sunlight). Once cured the blast profile is fully protected from further contamination. A 2nd coat of SolarSeal Resin is applied and the SolarTech Type VE55 applied immediately as a “wet on wet” application. This is then cured as previously and following a full cure the top carrier film is removed and the whole system coated in a final top-coat of SolarCoat resin and cured.

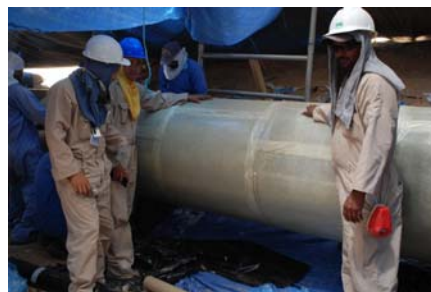
SolarTech application

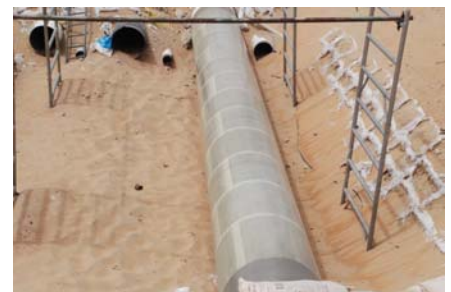
Completed application
